Preliminary Assessment Screening (PAS) Summation

1.1 SUMMARY

A preliminary site assessment was conducted of the site of the proposed Port Everglades expansion and deepening. As the areas considered for project deepening no longer include any upland disposal sites located adjacent to, or nearby the Port Everglades, the task was simplified. The hazardous and toxic waste evaluation revealed that the deepening event is in the vicinity of industrial facilities, ad hoc warehouse or storage areas, and petroleum storage facilities, but none of these areas are to be directly impacted. The report also provides documentation of numerous small spills which are not unusual for a busy port area. Likely through dilutions, actual cleanup remedial actions, and tidal currents pushing out the entrance all the residual effects have been weathered and eliminated. The material proposed for dredging will be evaluated for the suitability for ocean disposal in the Ocean Dredged Material Disposal Site and that will be the final test of the contamination of the material. The testing may include sediment chemistry as well as bioassays.. It is very unlikely that any significant contamination lingers. This re

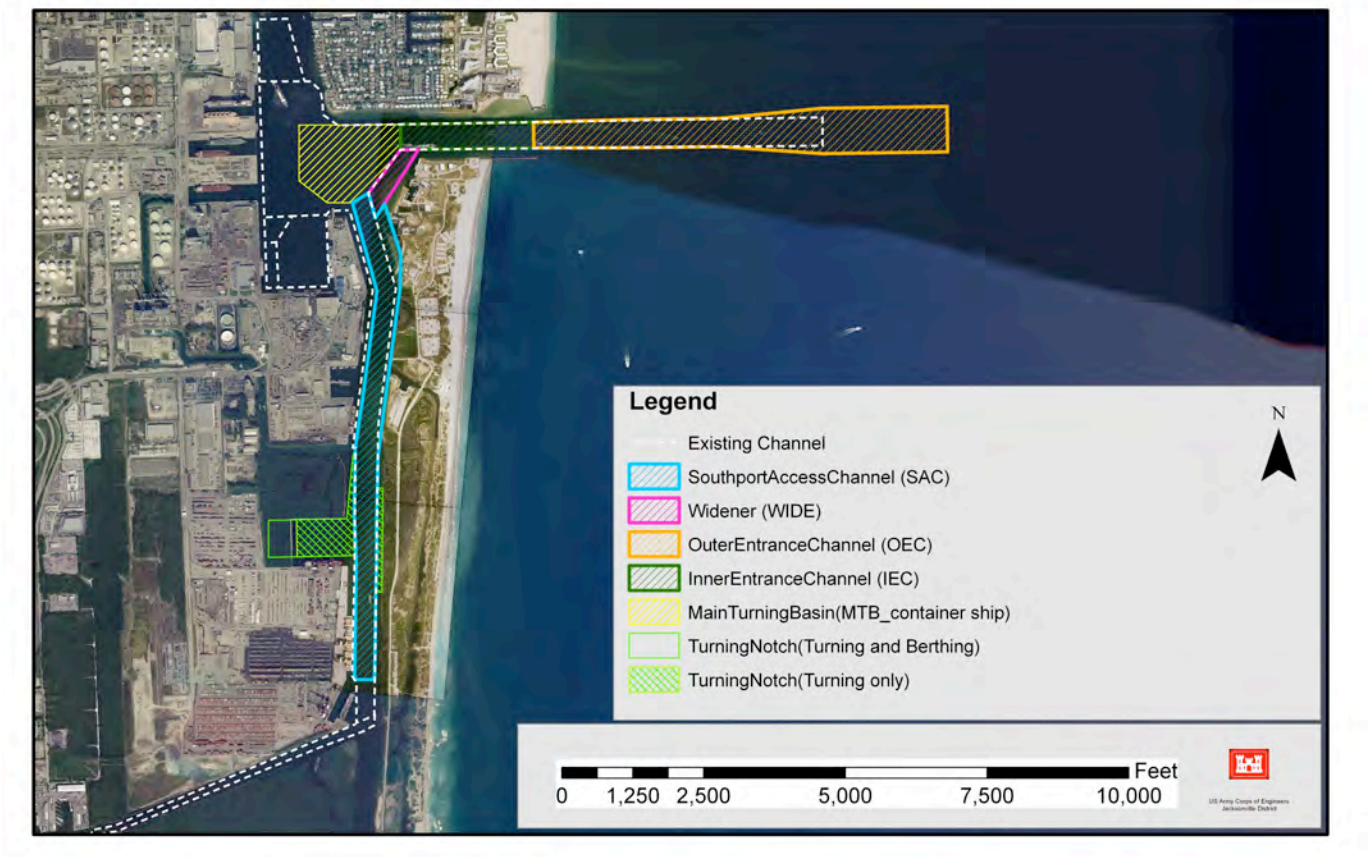
Project details and Location Map..... Figure

1.4.2 Physical Setting Source(s) The Project details and Location Map figure A1 indicates that the dredging sites are located within the developed seaport operation area.

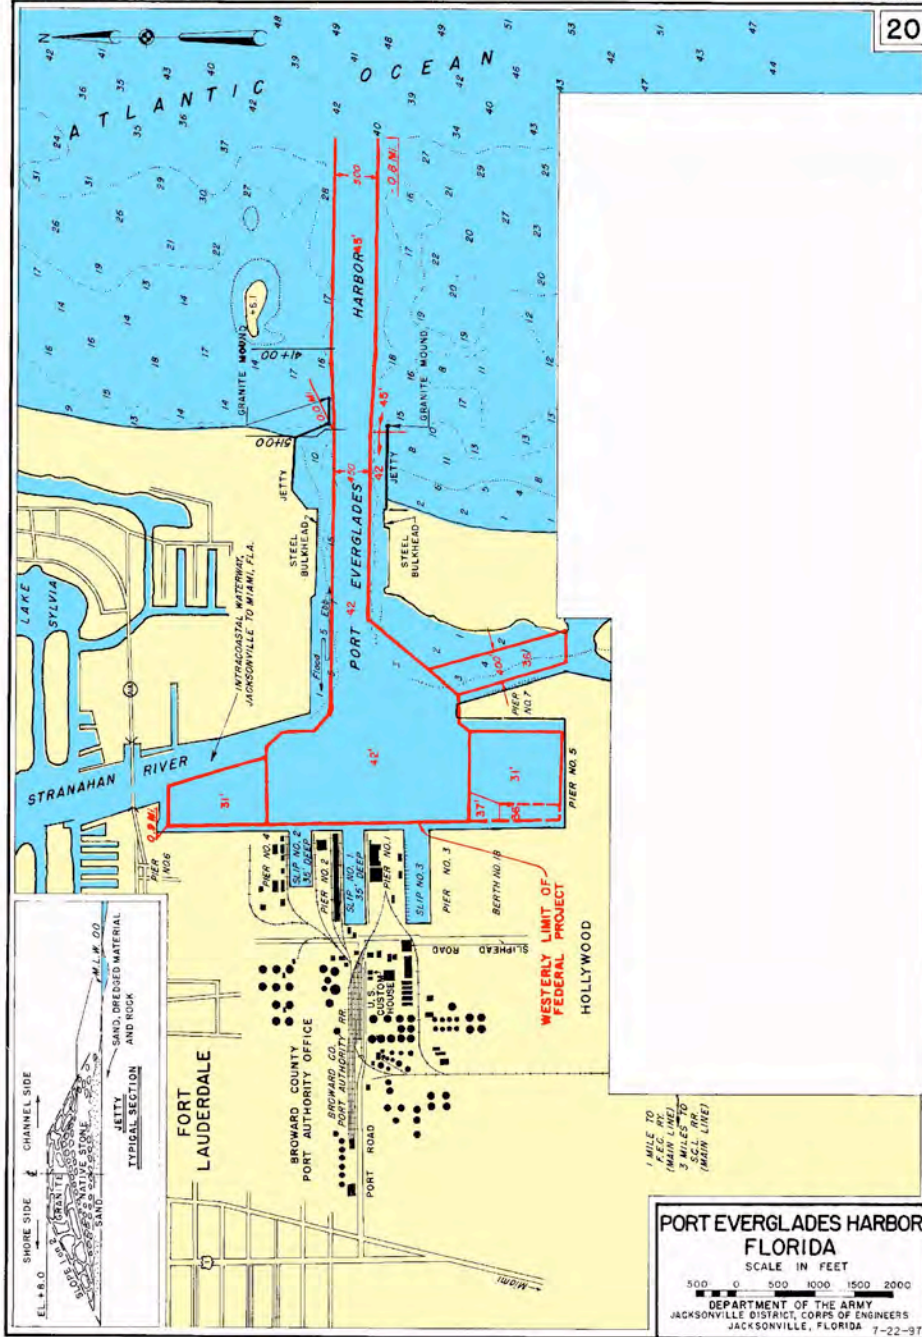
Historical uses Location Map.....Figure A2

1.3.7 Past Uses of the Property (to the extent identified). The past uses of the port are the same as the current use. Since this is not an upland site this is N/A. See Historical uses Location Map Figure A2

1.3.8 Current and Past Uses of Adjoining Properties (to the extent identified) By all indications observed throughout the site investigation, the adjoining properties relate to port operations. The dredging sites are surrounded by parking lots, roads, a metal recycler, etc. Historical uses Location Map Figure A2

1.4.3 Historical Use Information Is provided on the included layout map Historical uses Location Map Figure A2
:

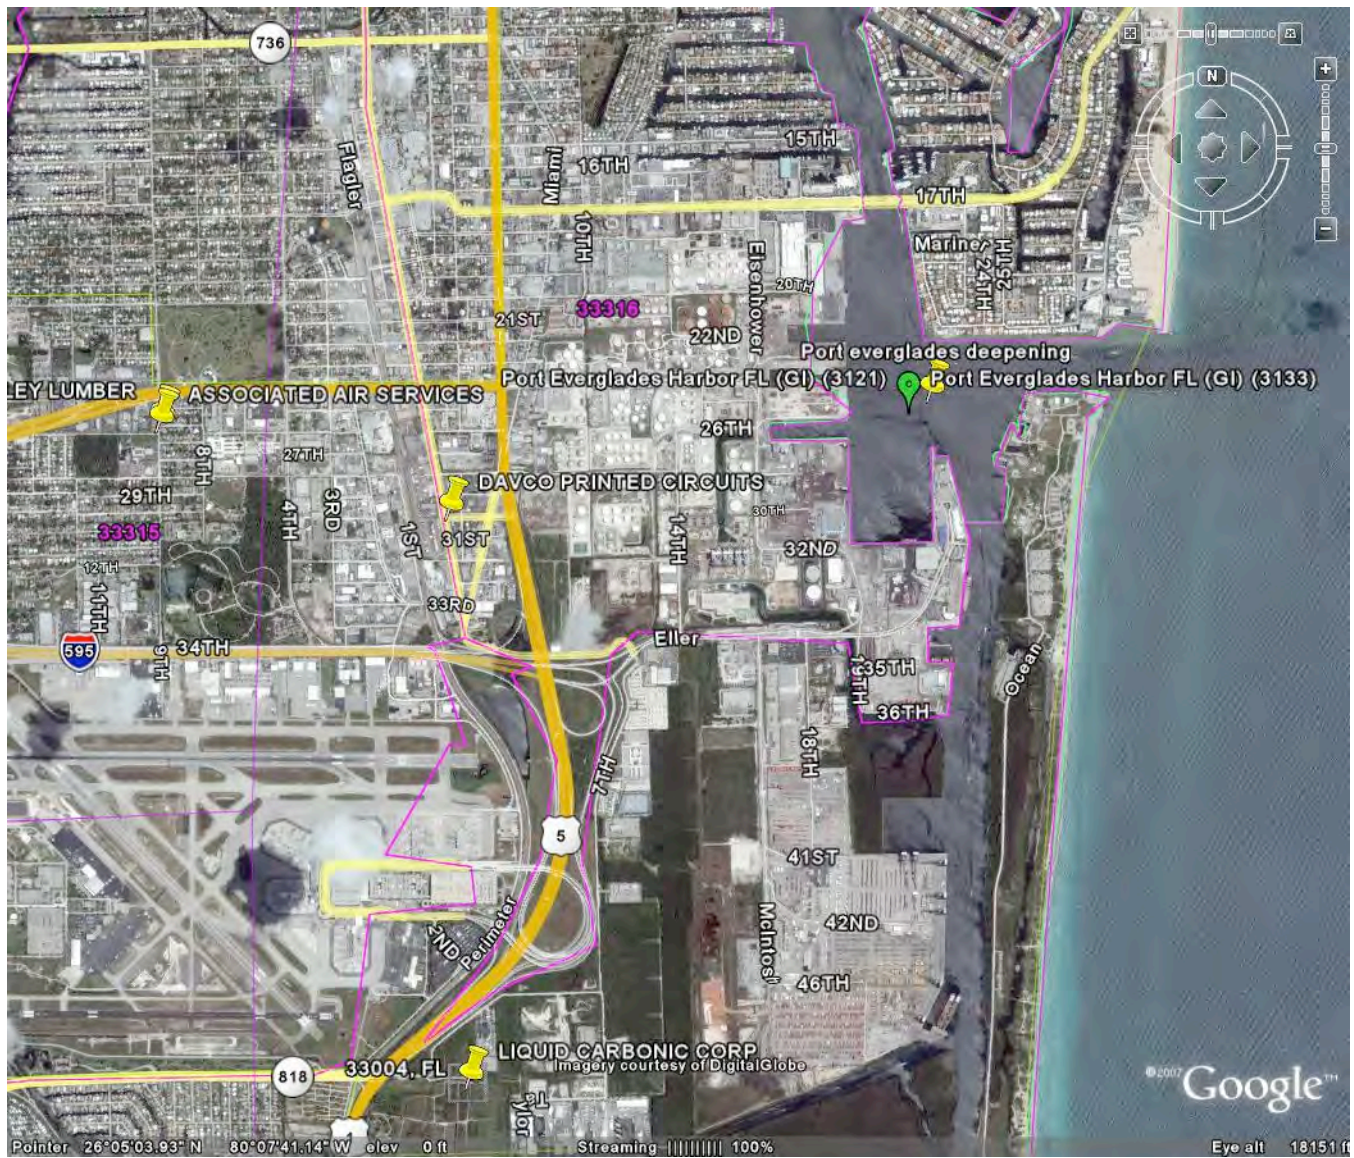
Non NPL CERCLIS. Site Location Map.....Figure A4

1.5.6 Physical Setting Analysis, if migrating Hazardous Substances are an issue. Migration of hazardous substances from pollution sources off-site was considered. Four “non NPL CERCLIS sites were found in the vicinity none of which appear to be close enough to have ever impacted the basin
